Polaris RZR XP1000 Safety Recall Z-16-01 Identification

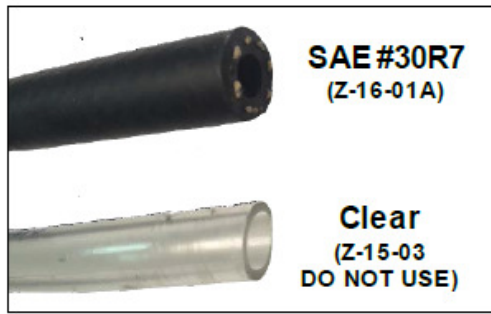
Z-16-01-A. *Fuel Tank Vent line replacement.*

Identified by the replacement vent line being black.

The original vent lines were clear

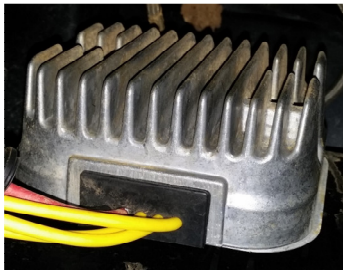
Z-16-01-C. *Voltage Regulator replacement.*

New Regulator is smaller

Old Regulator

New Replacement Regulator

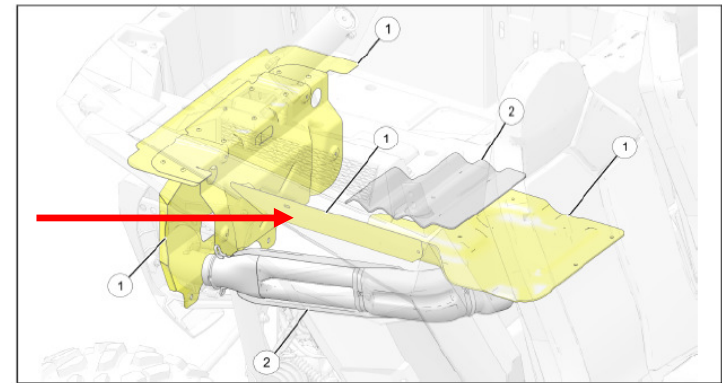
Z-16-01-D. *Heat shield replacement.* Heat indicated by the

red arrow is not present with the original shielding.

The other 3 shields in yellow have been upgraded

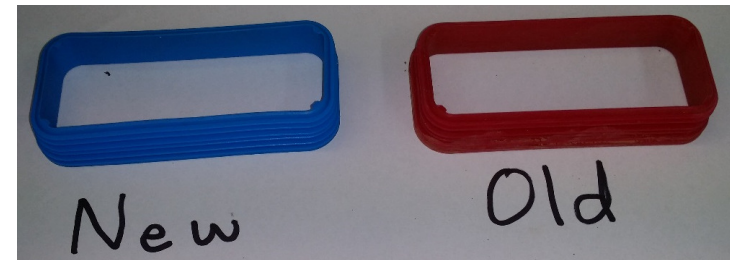
Z-16-01-E. *Fuse Box Seal Replacement.*

Old seal is red, replacement new seal is blue
